Manhole Inspection Summary

Manhole # S19I1_005MH

Insp Date: **4/18/08 1:05 PM**

Location Address: **2442 harriet av**

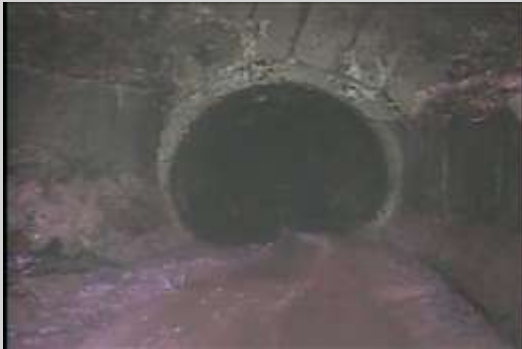
12 O'Clock Outflow

10 in. Circular Gravity Sewer
Pipe Out @ 12 O'Clock

Pipe Height: **9.6** (in.) Rod and Bar (Angled)
Pipe Material: **Clay** ☐ Pipe Lined
Invert Depth: **12.85** (ft.) Flow Characteristics: **Fast**
Deposits: ☒ None ☐ Mud ☐ Sludge ☐ Debris ☐ Grease
Silt Depth: **0** (in.) Deposits Extent:
Infiltration: **None** Pipe Seal Cond: **Sound**

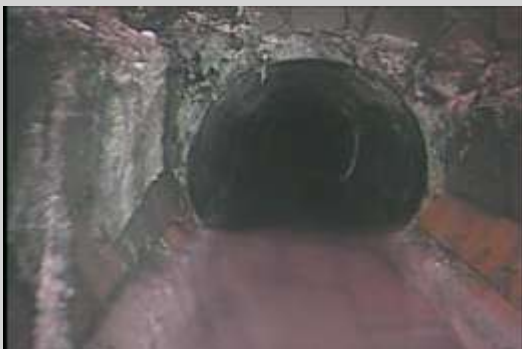
6 O'Clock Inflow

10 in. Circular Gravity Sewer
Pipe In @ 6 O'Clock

Pipe Height: **10.8** (in.) Rod and Bar (Angled)
Pipe Material: **Clay** ☐ Pipe Lined
Invert Depth: **12.64** (ft.) Flow Characteristics: **Fast**
Deposits: ☒ None ☐ Mud ☐ Sludge ☐ Debris ☐ Grease
Silt Depth: **0** (in.) Deposits Extent:
Infiltration: **None** Pipe Seal Cond: **Sound**

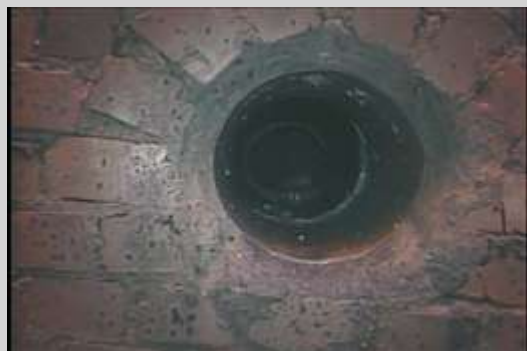
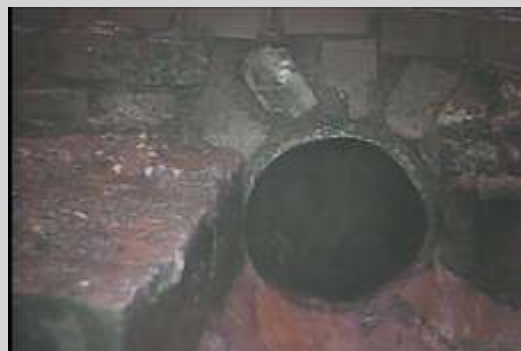
9 O'Clock Inflow

8 in. Circular Gravity Sewer

Pipe In @ 9 O'Clock

Drop In @ 9 O'Clock

Pipe Height: **8.4** (in.) Rod and Bar (Angled)

Drop Condition: **Open**
